Engineered Building Inspections Ltd.

INSPECTION REPORT

INSPECTED PROPERTY		CLIENT INFORMATION	
Address:	53__ Manor Street, Burnaby, B.C.	Name / Address:	
Date of Inspection:	09 DECEMBER 2003		
Time Started:	13:30		
Weather Conditions:	Cloudy, Cold	Home Phone:	
Ground Conditions:	Damp	Work Phone:	
Those Present:	Realtor & Buyer	E-mail or Fax # :	
Occupancy:	Vacant	Referred By:	Realtor

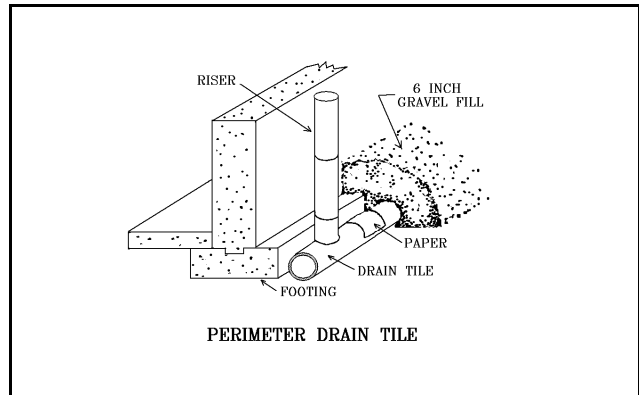
The draintile risers that are used to accommodate collected roof water are typically connected to a draintile system installed at the base of the perimeter foundation (see sketch). This draintile is designed to protect below-grade areas from moisture penetration problems. Silt accumulations and root penetrations, which may obstruct the system to varying degrees, could exist. Sub-surface investigations which would provide information on the condition of the draintile system are beyond the scope of our inspection. Draintile system repairs are a labour-intensive, potentially costly proposition. No problems were found in this instance. Further direct enquiries to the owners regarding their knowledge of

possible past moisture penetration problems are, nevertheless, recommended.

If a problem is identified or if one materializes at some later date and flushing or other measures fail to resolve the problem, the peak roof water loads on the draitile system can be reduced by diverting the collected roof water away from the foundation. This is typically achieved with downpipe extensions and splash pans. Re-positioning of the gutter drains to less problematic locations is sometimes also possible. With diversions, a reduction in peak volume is achieved by forcing the collected roof water to percolate through the soil before reaching what remains of the draitile system.

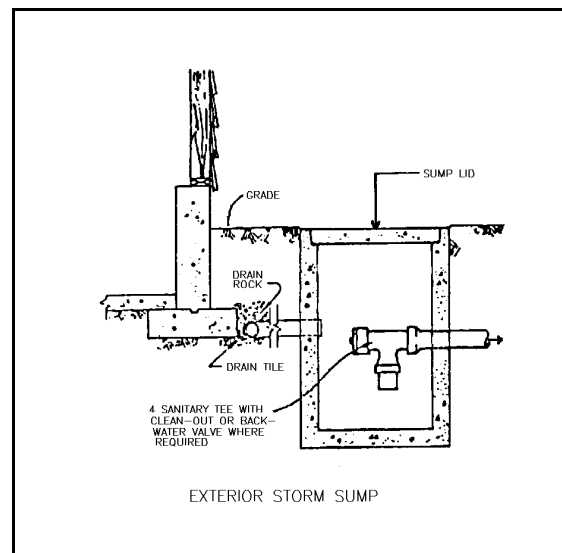
Installation of a storm sump (see sketch) is required for most modern residential construction. The sump was located at the northwest corner of the property. Inspection of the interior indicated silt accumulations that require present removal. The sump is designed to protect the city drains from silt entry associated with gutter accumulations and soil fines that invariably enter the draitile system. Access via the sump lid permits removal of those accumulations. Water flowing into the sump exits via a protective elbow to the city sewer. The elbow extending down into the sump water is fitted to provide an air seal and to prevent direct silt entry into the city drains. The sump should be inspected periodically to permit timely removal of interfering silt accumulations. Blockage of the exit elbow can result in water back-up into the draitile system and possible associated flooding of surrounding areas.

5. Remove any silt accumulations from the exterior sump and provide periodic future maintenance.
6. Replace the deck access stairway using treated wood material. Support the stairway stringer bases on moisture-free footings.

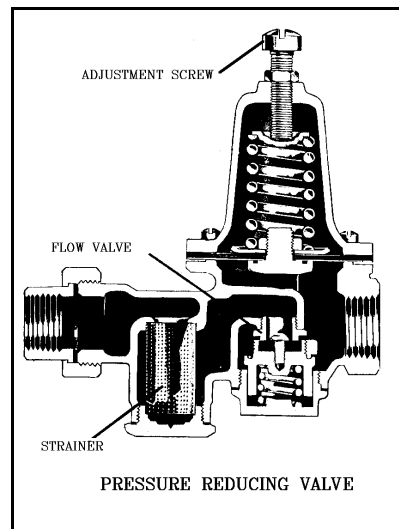
Supply plumbing was copper pipe. Past news releases warn of previous use of substandard copper pipe. We have not detected any related pipe leakage problems associated with newer residential structures or where older pipe sections have been replaced. The problem appears to be confined to warm-water systems in larger apartment or commercial buildings where high-velocity continuously circulating warm-water systems are incorporated. The life expectancy

of copper supply piping in residential installations without circulating systems is between 40 and 50 years. Leakage was observed in a section of pipe located above the hot water tank. Immediate repair of the leakage is required.

12. Modify the lower fireplace to reduce cold air drafts.
13. Adjust the installed pressure reducing valve to a more tolerable level.
14. Repair the minor supply pipe leakage near the hot water tank.
